White Rock Lake Trail Erosion: Preliminary Engineering Report

April 2024

City of Dallas Parks and Recreation

FREESE AND NICHOLS, INC.

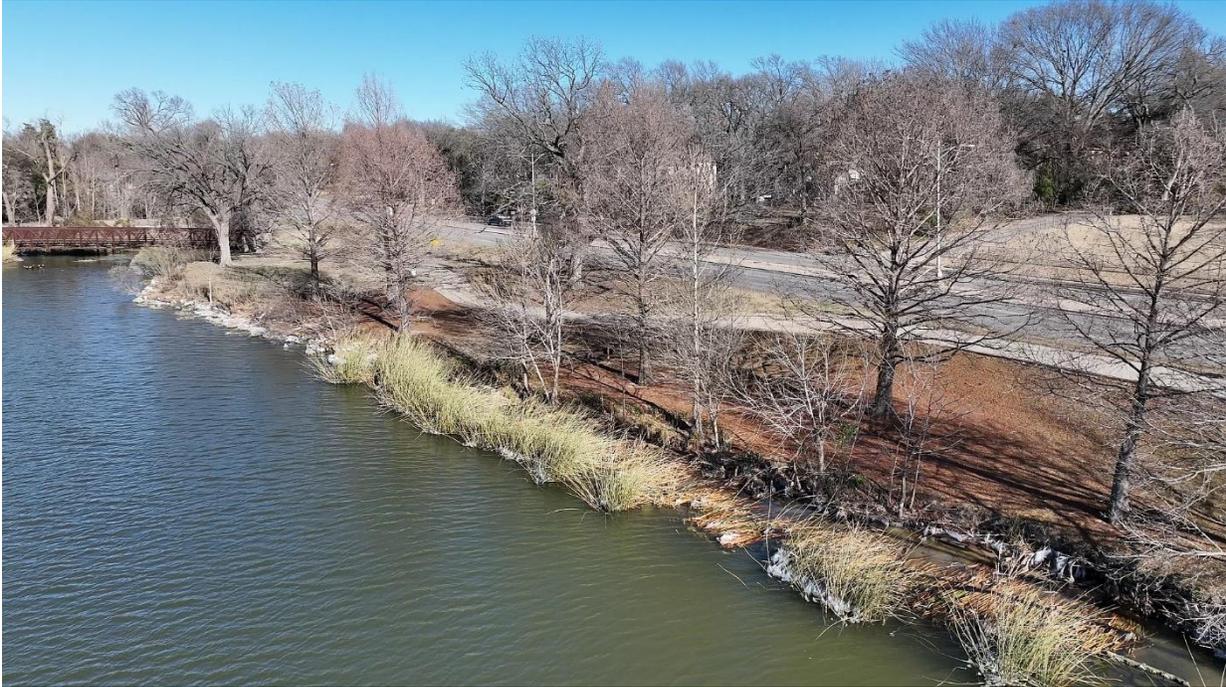
Between Station 0+00 and 5+50 shoreline bluff heights are relatively low (between 2 – 5 feet). The slope of the bluff varies between shallow (30-degrees) and near vertical. Toe scour derived from wave action was observed, becoming more frequent progressing toward station 5+50. Aquatic vegetation and infrequent cypress trees are present which help protect the shoreline. However, remaining vegetation consists of turf grasses, which provides limited surface protection. Rock riprap can also be found along the toe and in the water where shoreline retreat has progressed up to 10-feet behind the protective measures, which show the location of the historic shoreline. While shoreline retreat will continue slowly, there are minimal threats to infrastructure, except at a 12-inch reinforced concrete pipe stormwater outfall and headwall at Station 4+00. This outfall has been undermined by shoreline retreat. Photo 1 and Photo 2 show the representative conditions of these stations.

Photo 1 – View looking east toward Station 2+00 to 5+00

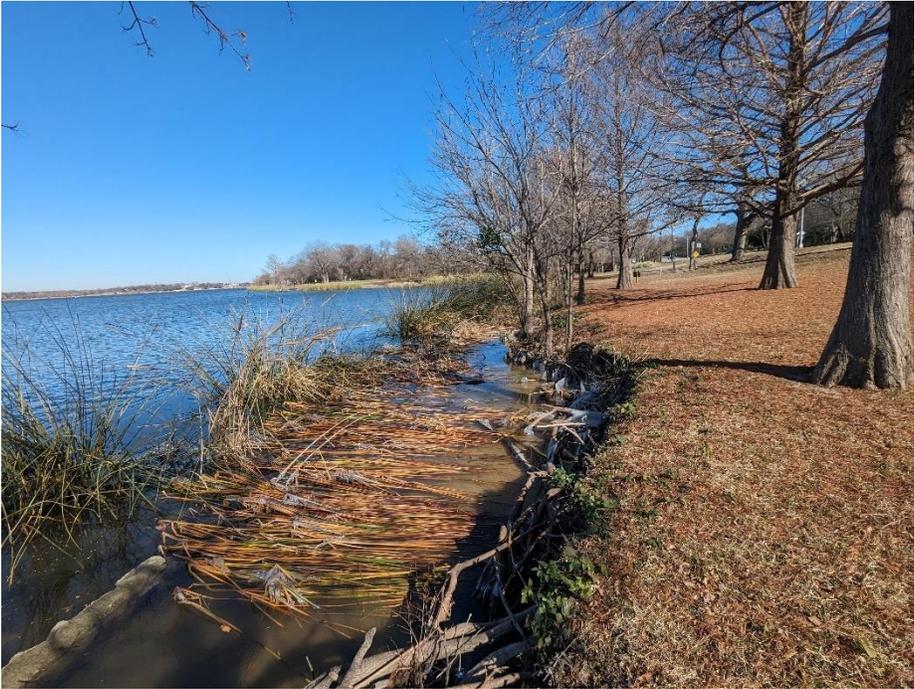
Photo 2 – View looking northeast from Station 4+00

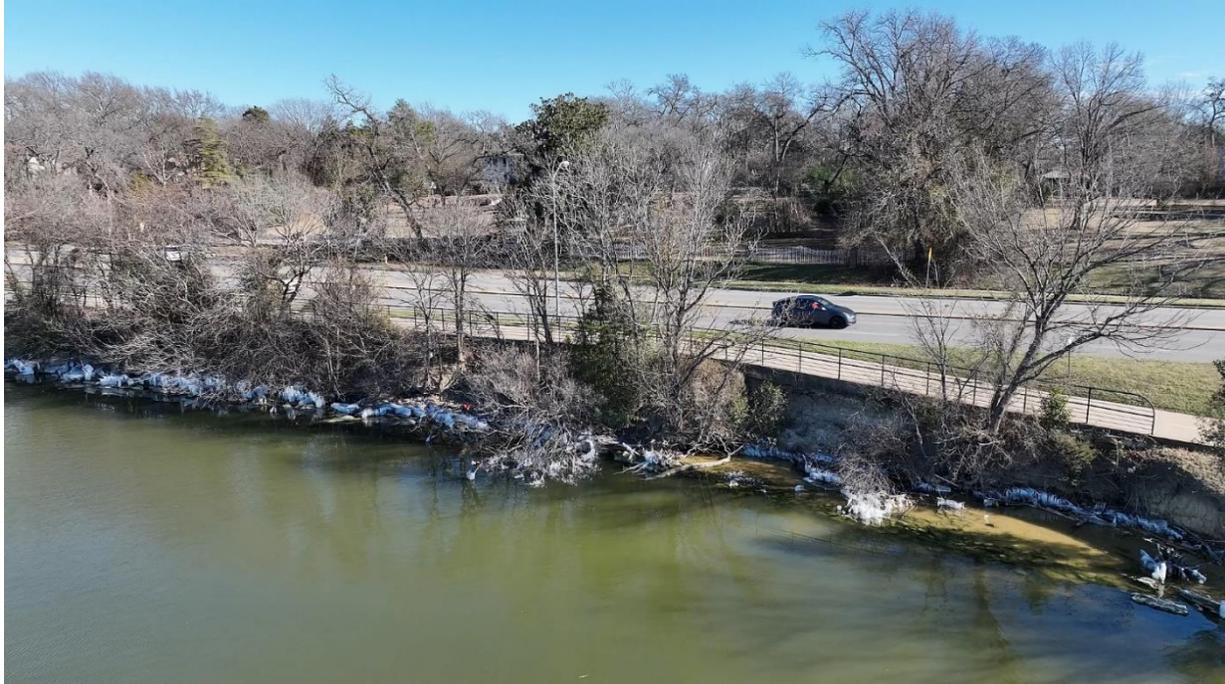
Between Station 5+50 and Station 13+00 the shoreline and trail are vulnerable to continued erosion. The shoreline bluff heights increase to approximately 10-feet and have a slope between 45-degrees and vertical. Numerous mass failures were observed and up to 30-feet of shoreline retreat has occurred. These mass failures expose the underlying alluvial terrace deposits and foundation of the trail. Rock riprap bank protection composed of old road base is present on the slope and toe of the shoreline, but shoreline retreat has persisted behind these protection measures in many locations. Woody vegetation (trees) and vines are present on segments of shoreline that have not been eroded. This segment of shoreline may be most susceptible to erosion because of its tall bluff heights and because it is the most exposed part of the study area along the lake (i.e., this segment of shoreline has a longer fetch distance for wind generated waves). Photo 3 and Photo 4 show the representative conditions of these stations.

Erosion is an immediate threat to the trail system and Garland Road. A 2-foot x 3-foot rectangular concrete stormwater outfall and headwall at Station 8+00 is also threatened by ongoing shoreline processes. Erosion is likely caused by a combination of wave action and a loss of global stability from rapid drawdown after storm events. This is evidenced by rock riprap toe protection and woody vegetation not providing protection against slumps. Furthermore, the observed bank material below the trail may be disturbed soil, which is more susceptible to internal erosion processes.

Photo 3 – View looking east toward Stations 9+00 to 12+00

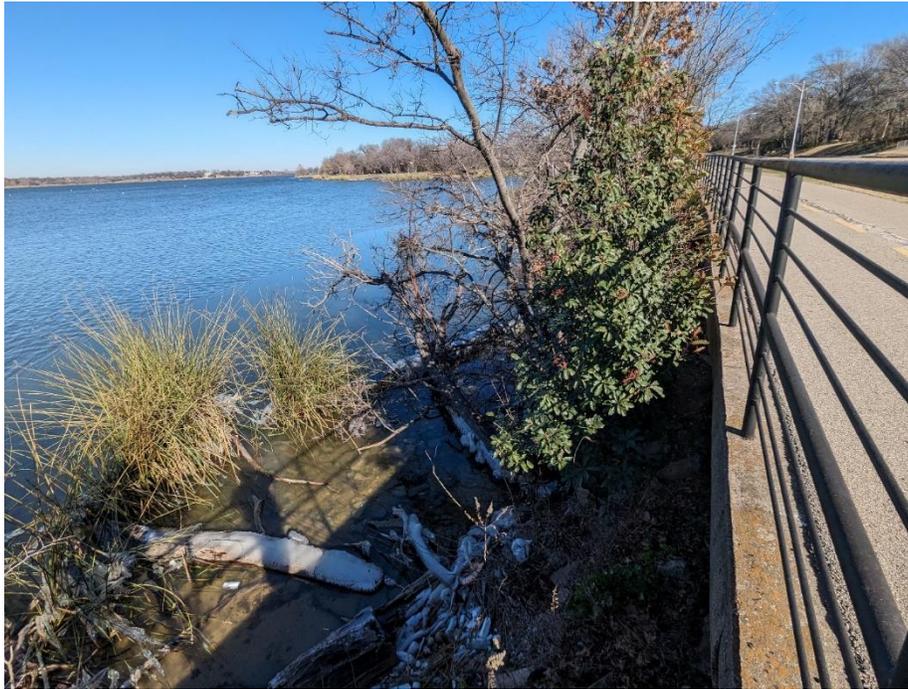
Photo 4 – View of looking northeast at Station 10+00

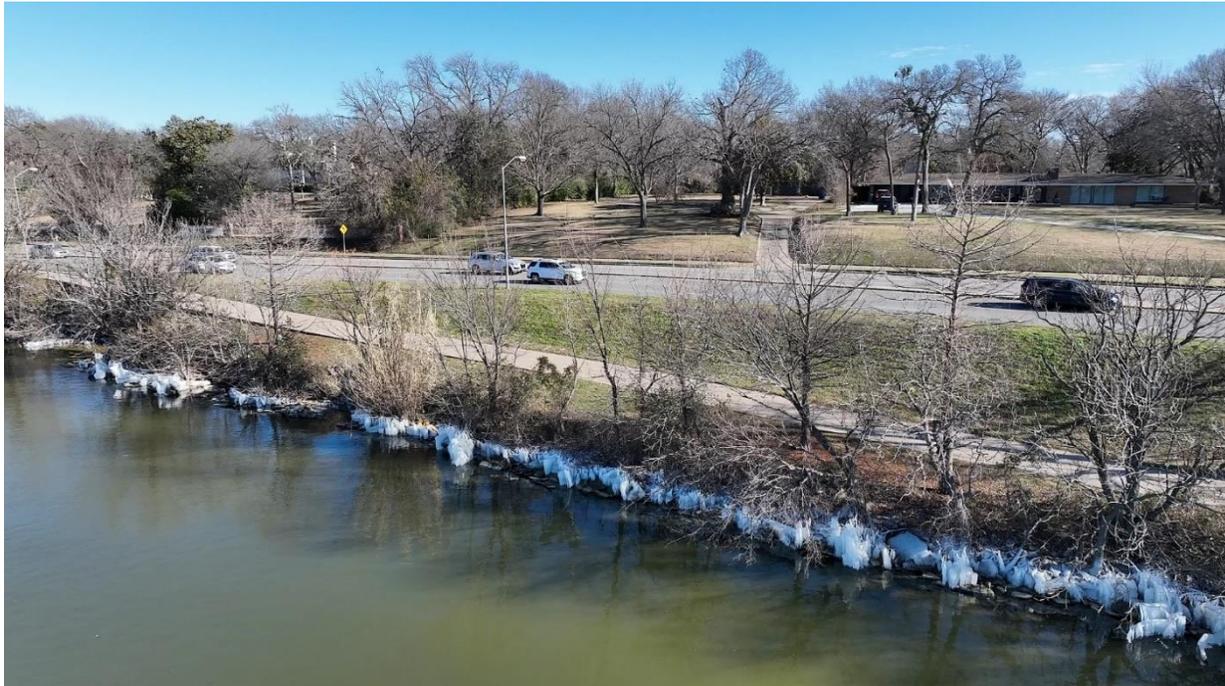
Between Station 13+00 and Station 16+50 the shoreline bluff height is approximately 6-feet tall with a slope between 30-degrees and 45-degrees. The shoreline within this section mainly consists of historic slumps that have since become revegetated with woody vegetation; however, turf grasses are also present at the top of the slope. Concrete rubble and rock riprap has also been placed along the toe of the slope, with mixed effectiveness against shoreline retreat. Photos 5 and 6 show the representative conditions of the shoreline between these stations.

Active erosion is most notable at Station 15+60, where the trail foundation has been exposed. Shoreline retreat will likely continue in isolated locations through time, but because the typical conditions (low bluff heights and trail proximity to lake) make erosion a lower threat to infrastructure compared to other sections of shoreline.

Photo 5 – View of looking northeast at Station 15+00 to Station 13+00

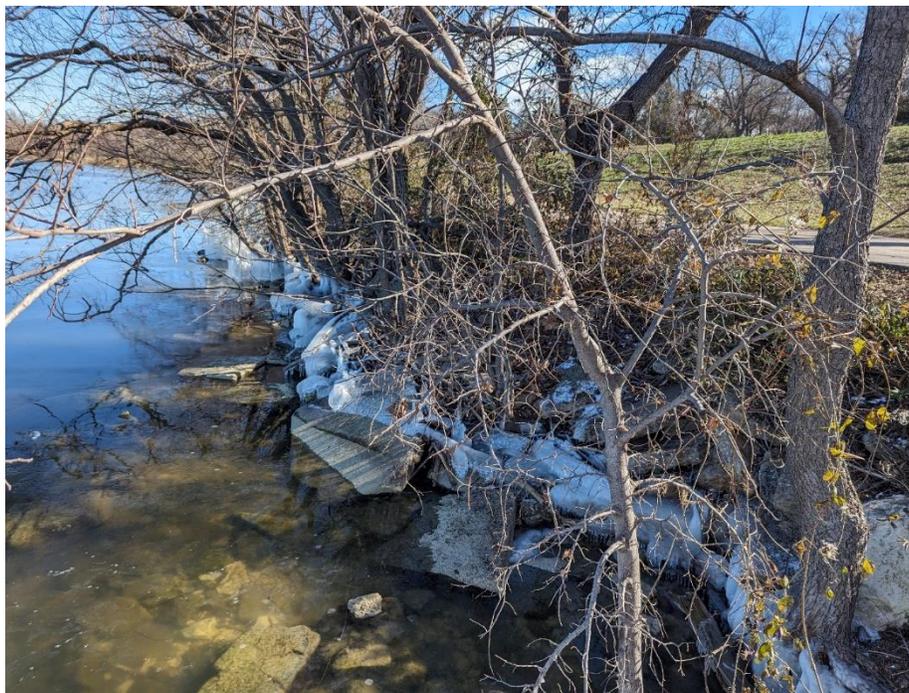
Photo 6 – View looking northeast at Station 15+50

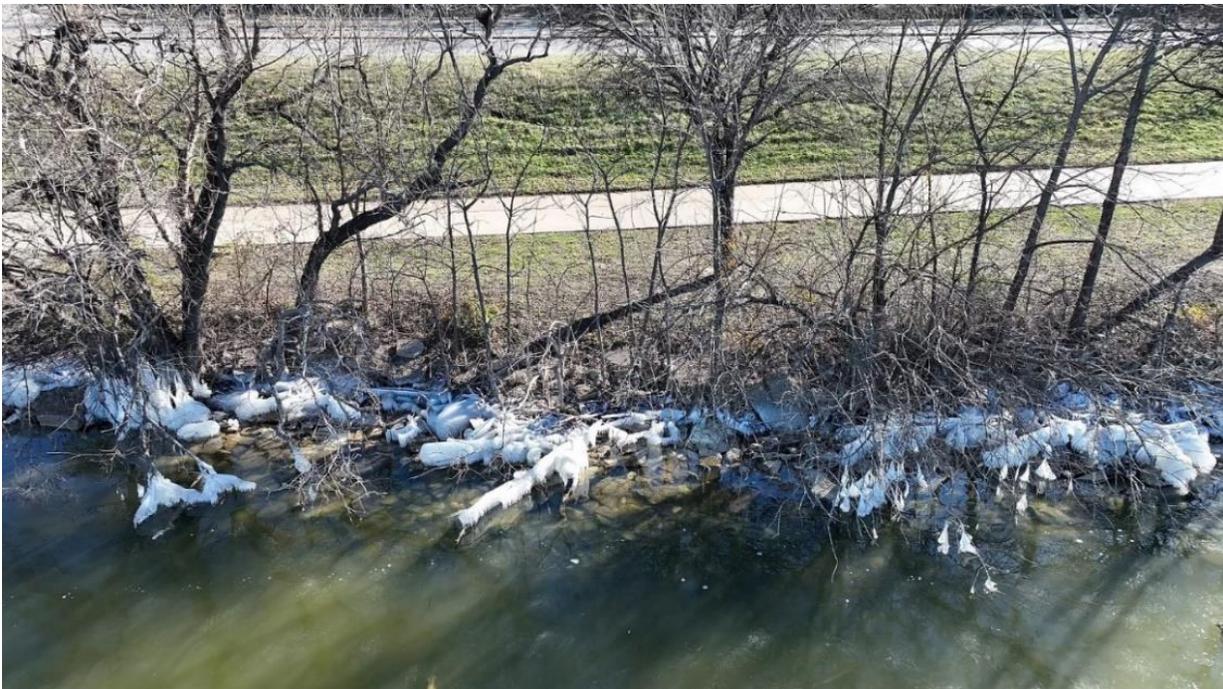
Between Station 16+50 and Station 13+00 the shorelines have a bluff height between 4 and 6 feet and are gently sloping at between 20- and 40-degrees. The shoreline has surface protection composed of both rock riprap along the toe and trees. Infrequent slumps are present, that have since revegetated. Photo 7 and Photo 8 show representative conditions of the shoreline within this section of shoreline.

Shoreline retreat may occur slowly in the future, but nearby infrastructure is not at risk of being impacted. Erosion is less prevalent within this section of shoreline because the vegetated shallow sloping banks and presence of toe armoring protect against wave action derived erosion and inhibit slope failures and slumping.

Photo 7 – View of shoreline at Station 18+00

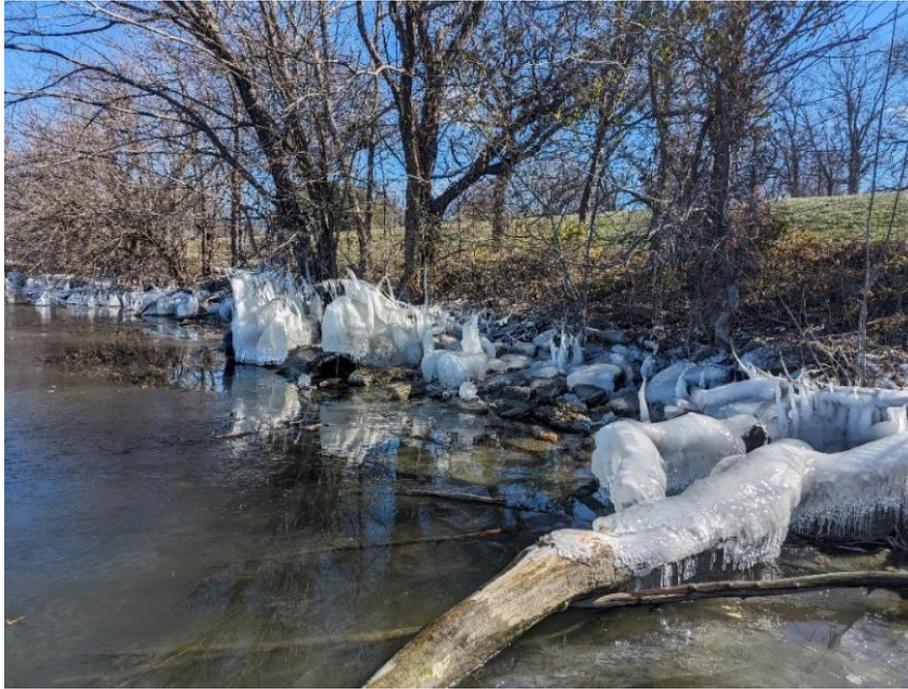
Photo 8 – View looking northeast at Station 19+00

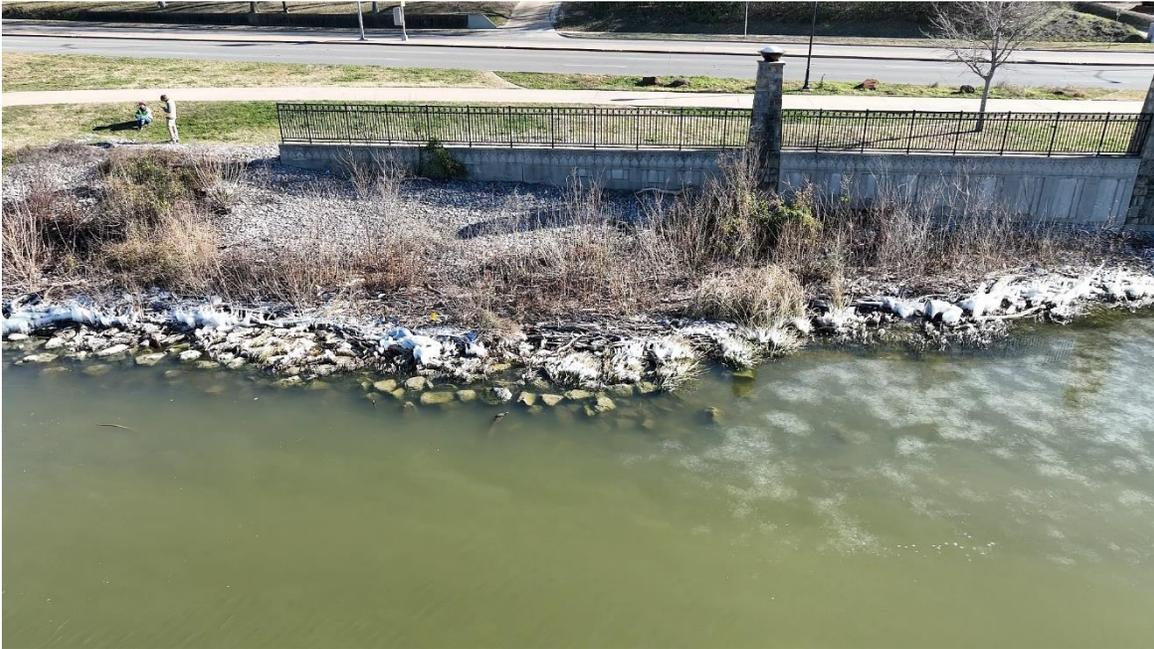
Between Station 19+50 and Station 23+00 the shoreline is composed of shallow sloping gabion mattress and rock riprap toe, and/or vertical concrete retaining wall. While trees are starting to grow within the gabion mattress, both protection measures are in good condition and appear to adequately prevent shoreline erosion impacts to adjacent infrastructure. Photos 9 and 10 show representative conditions between these stations.

Photo 9 – View of Shoreline at Station 20+50

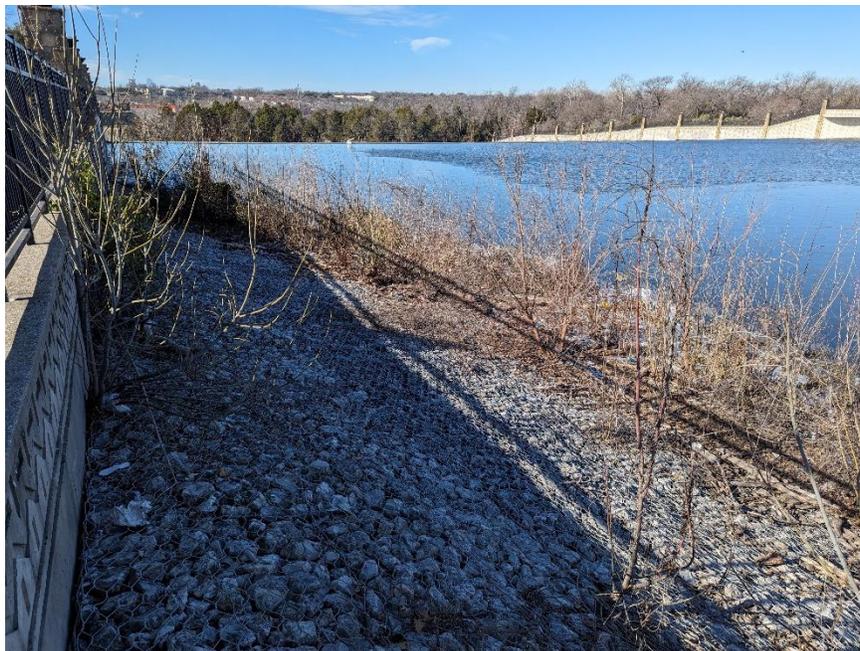
Photo 10 – View looking southwest from Shoreline at Station 20+00

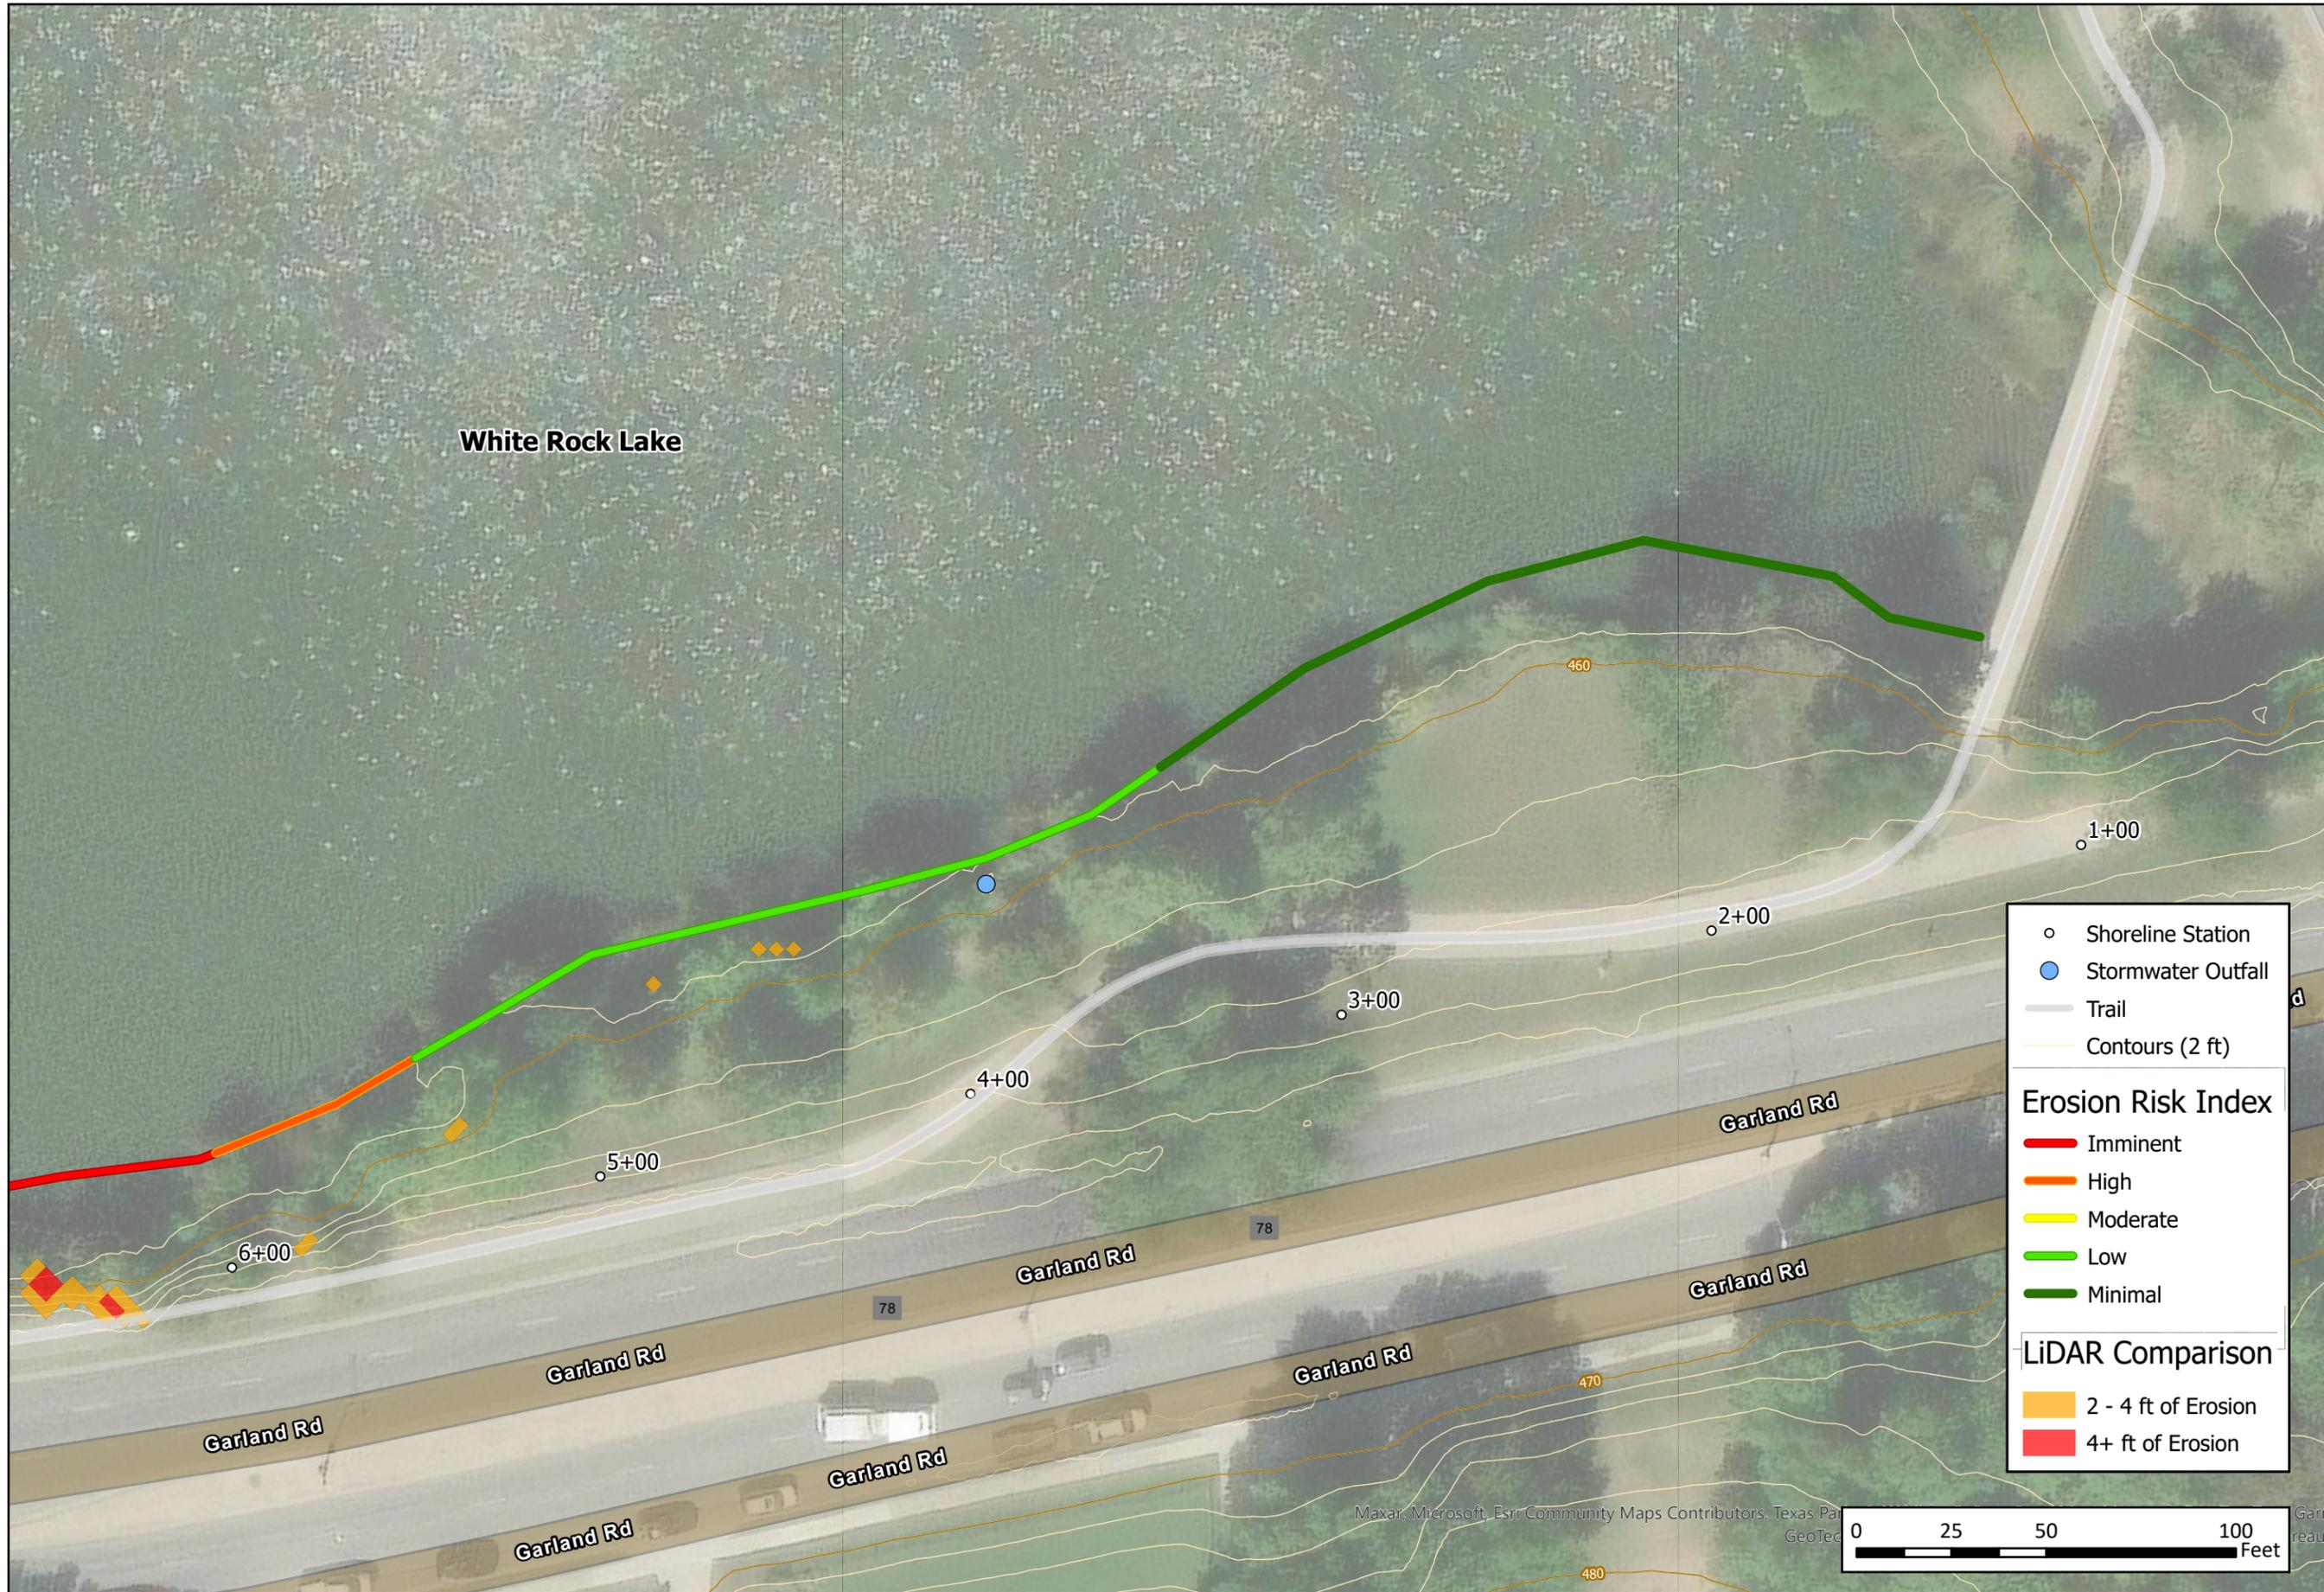
FN JOB NO	DPR232224	EXHIBIT	2
FILE	SGN_Working		
DATE	4/18/2024		
SCALE	1:500		
DRAFTED	02530

Exhibits 2 - 4 show the shoreline risk index within the project area. In general, areas of High and Imminent Risk of erosion impacts are present from Station 5+50 to 13+00 and 14+50 to 16+00. Between Station 13+00 and Station 14+50 there is Moderate Risk due to slightly taller streambanks and observed past slumping that has since revegetated at a shallower slope.

A comparison between available 1 meter (3.28 foot) resolution LiDAR data from 2009 and 2019 were also compared to evaluate elevation change between these two time periods (**Exhibits 2 - 4**). This analysis shows between 2.5-feet and 5-feet of elevation loss (erosion) has occurred in many locations within the project area. These locations correlate with location slumps observed during the site and the Erosion Risk Index.

Erosion Risk Index & LiDAR Comparison (2009 - 2019)
Station 0+00 - 5+50

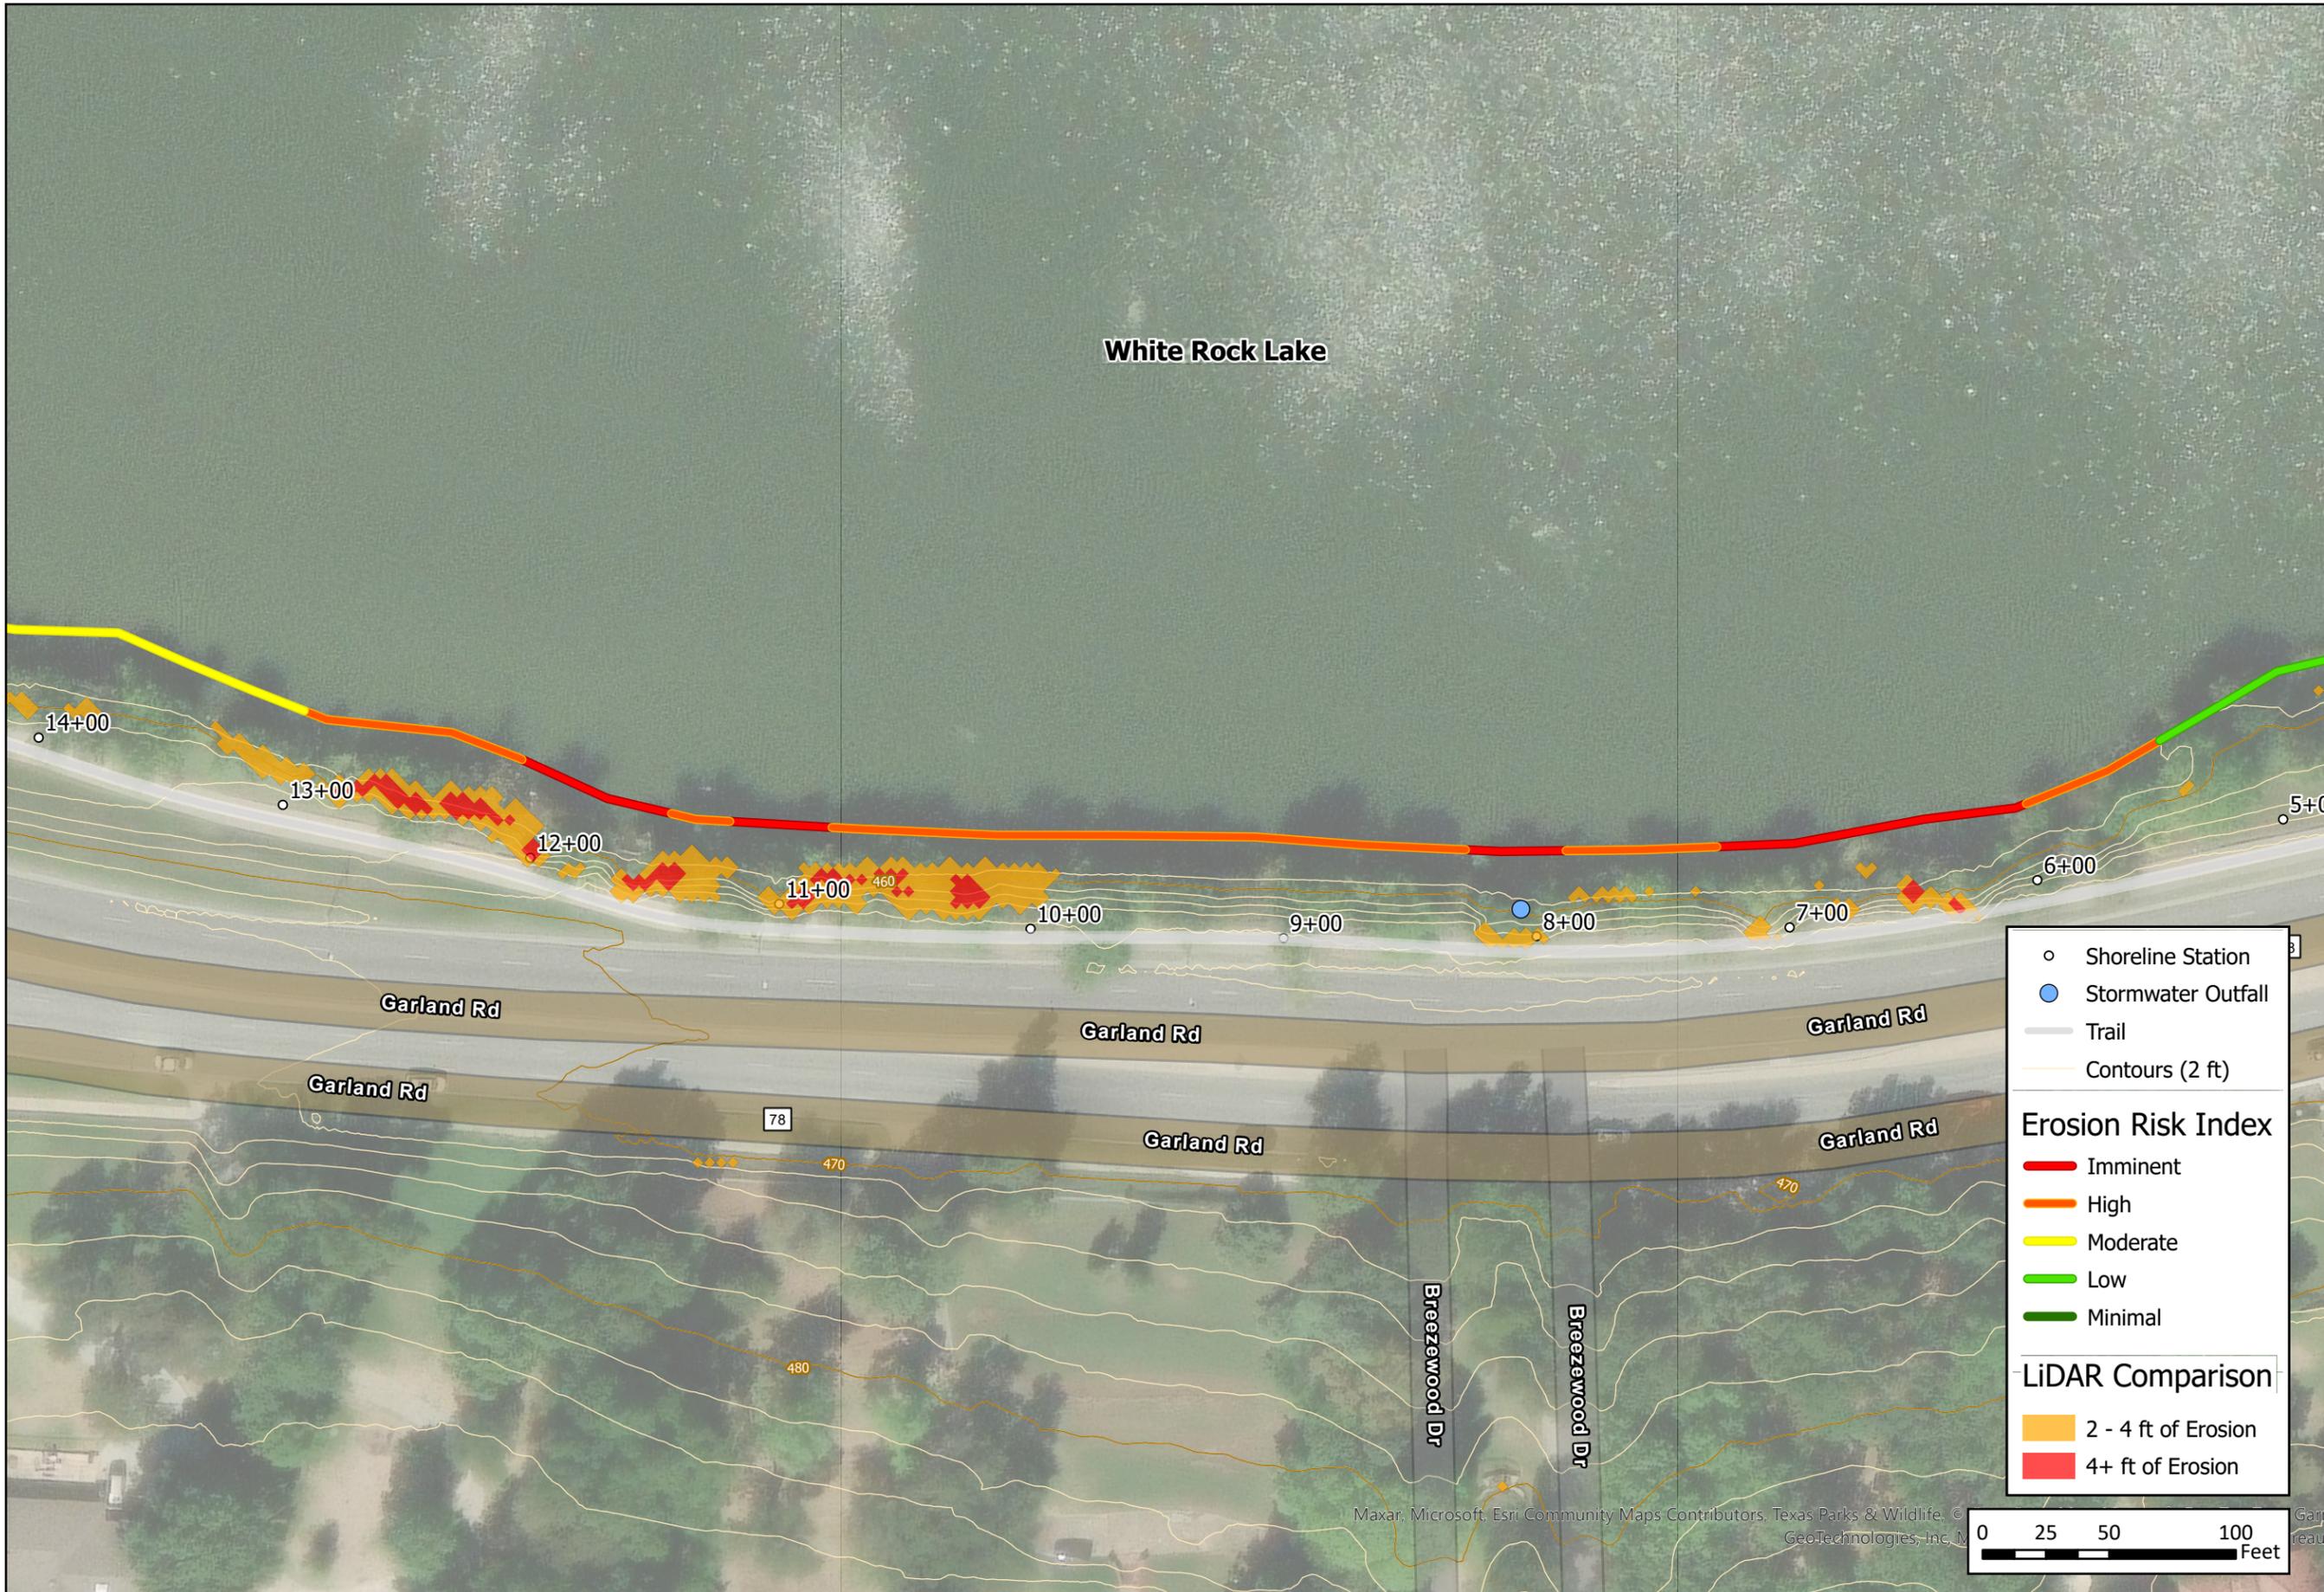
Erosion Risk Index & LiDAR Comparison (2009 - 2019)
Station 5+50 - 13+00

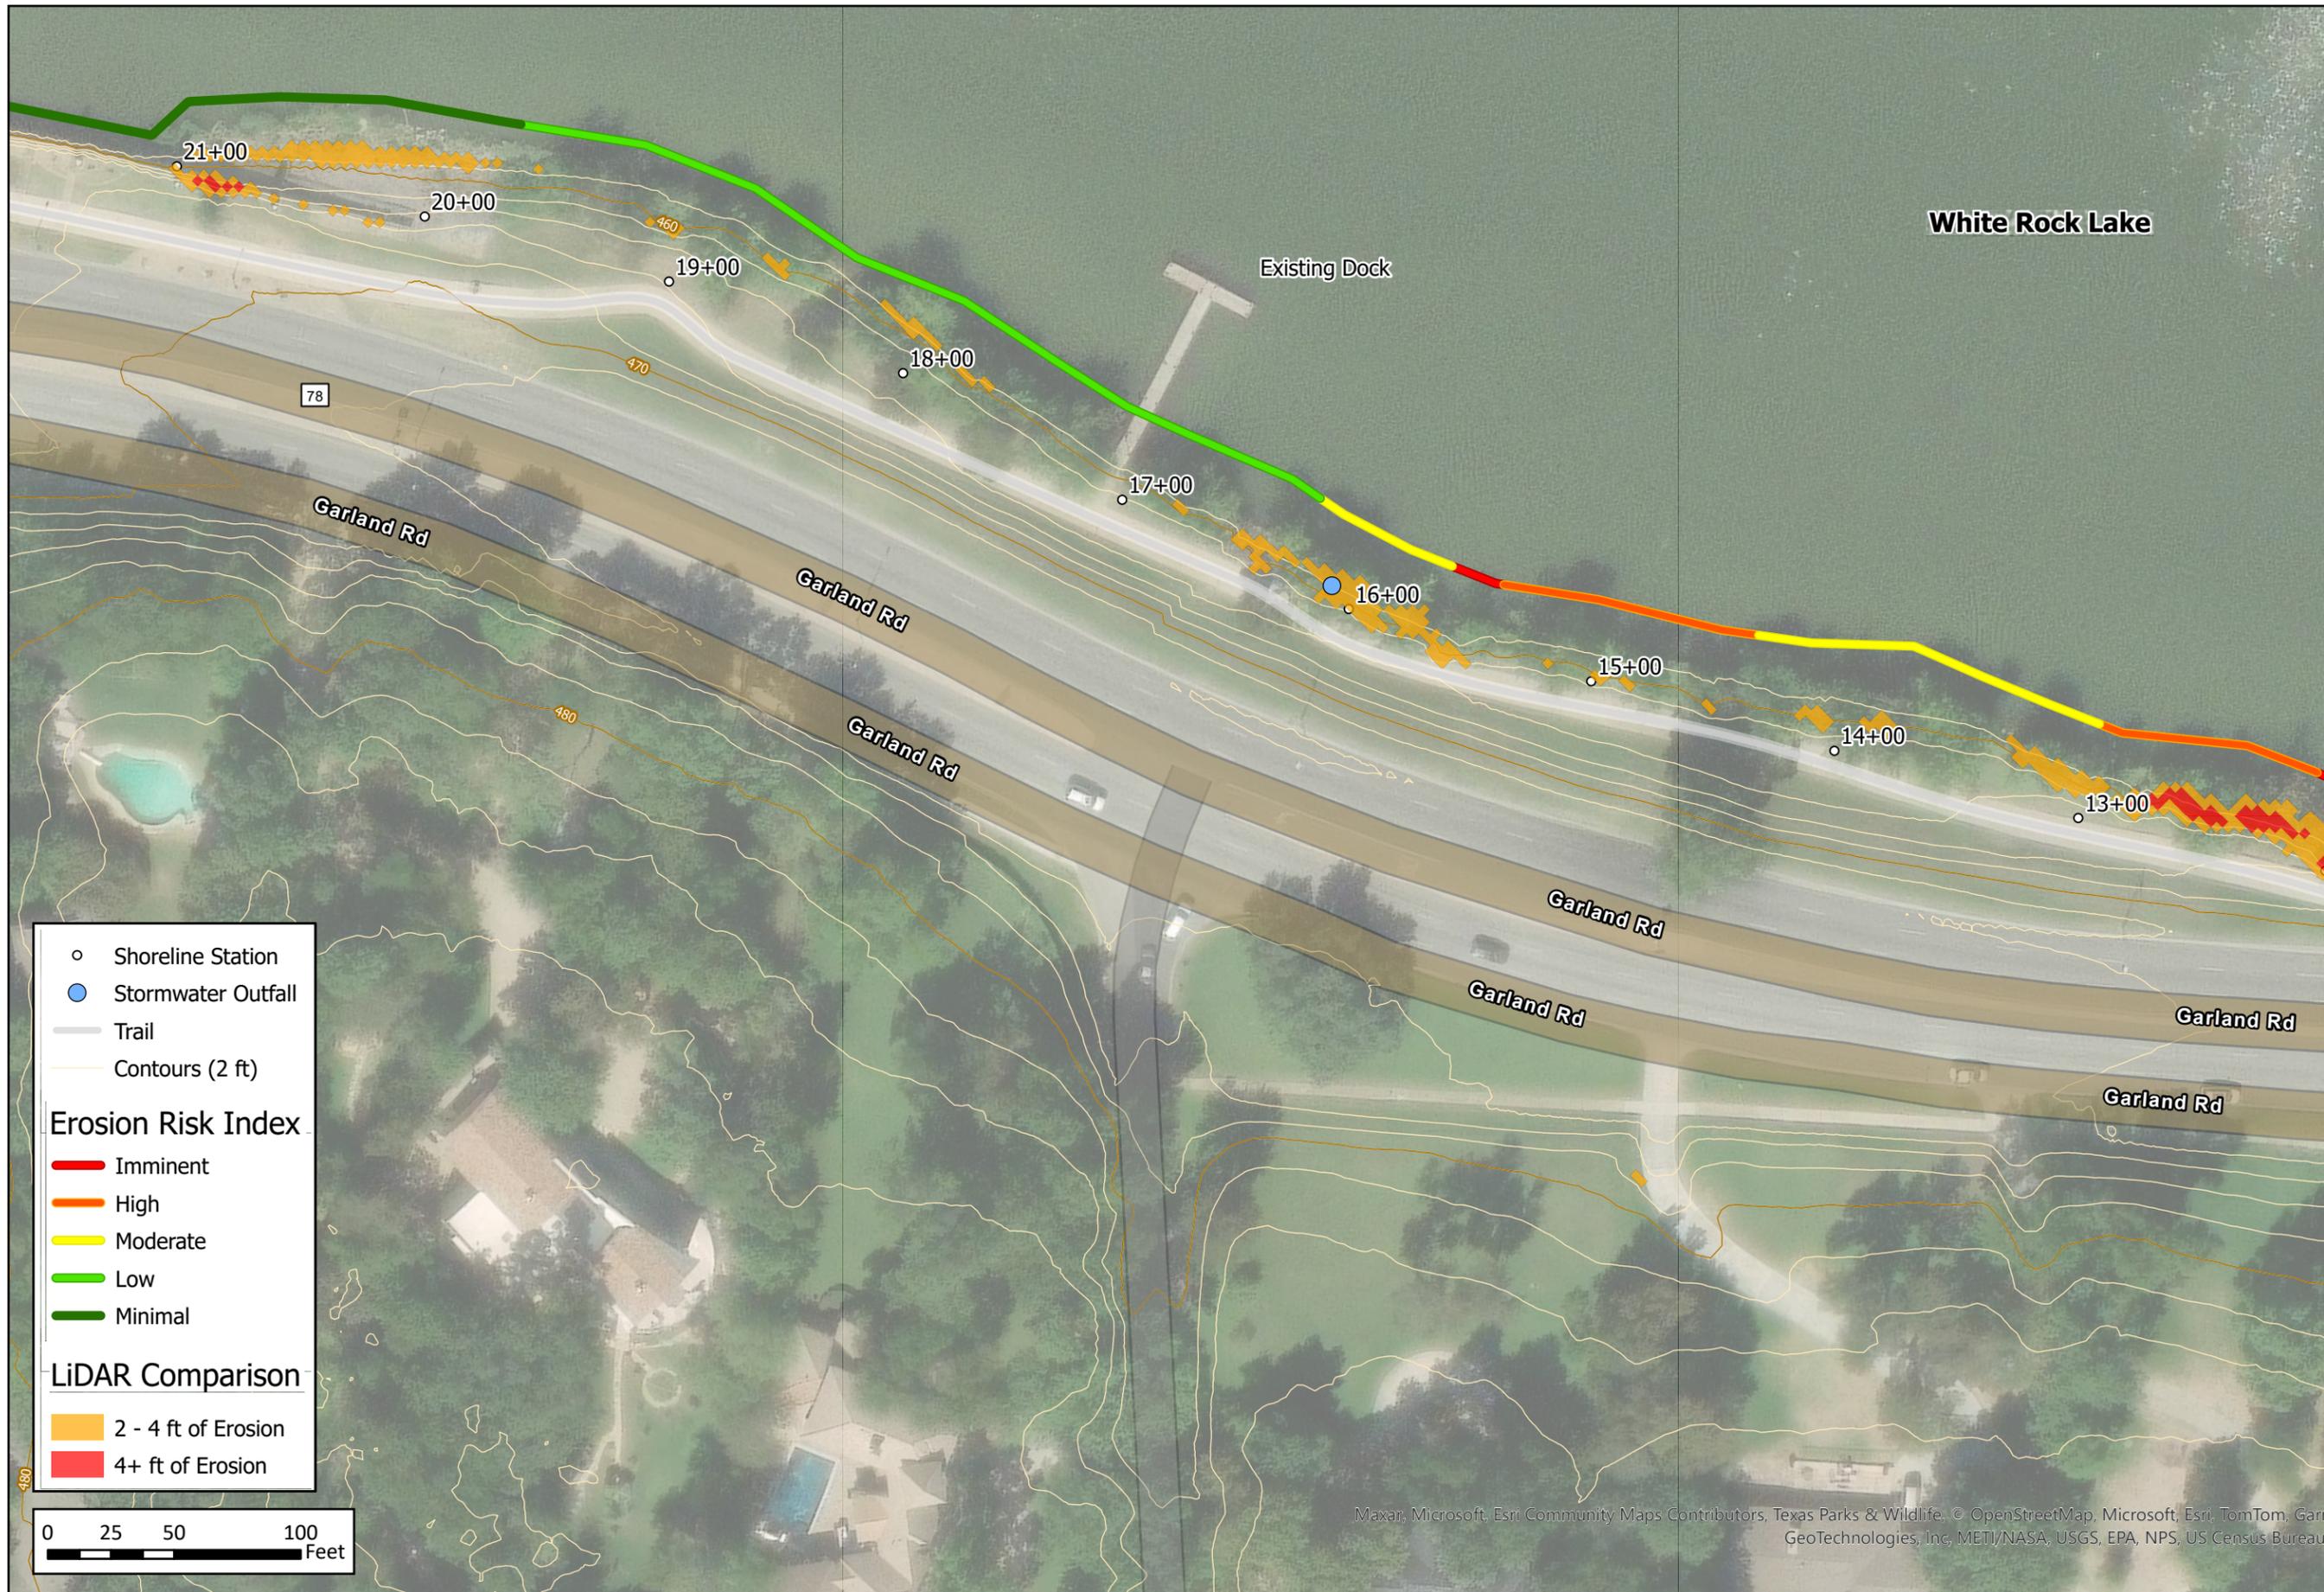
EXHIBIT				
4				
FN JOB NO	DPR23224	FILE	SGN_Working	DATE
				4/18/2024
			SCALE	1:750
			DRAFTED	02530

Station 13+00 - 21+50
